COLUMBIA

ACCIDENT INVESTIGATION REPORT

REPORT VOLUME 1
AUGUST 2003

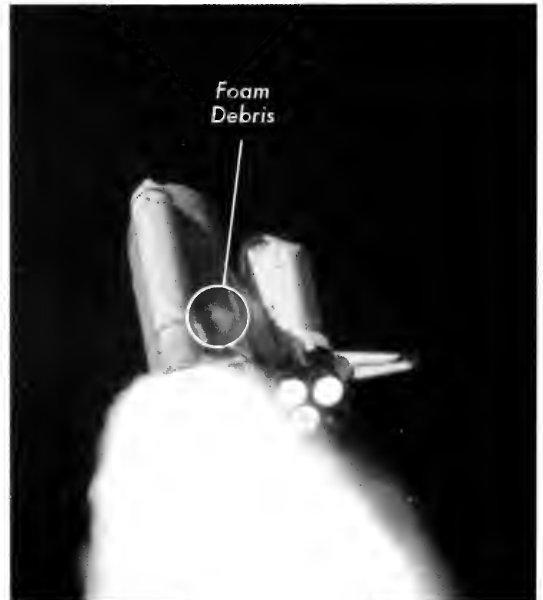
Figure 2.3-2. A shower of foam debris after the impact on *Columbia's* left wing. The event was not observed in real time.

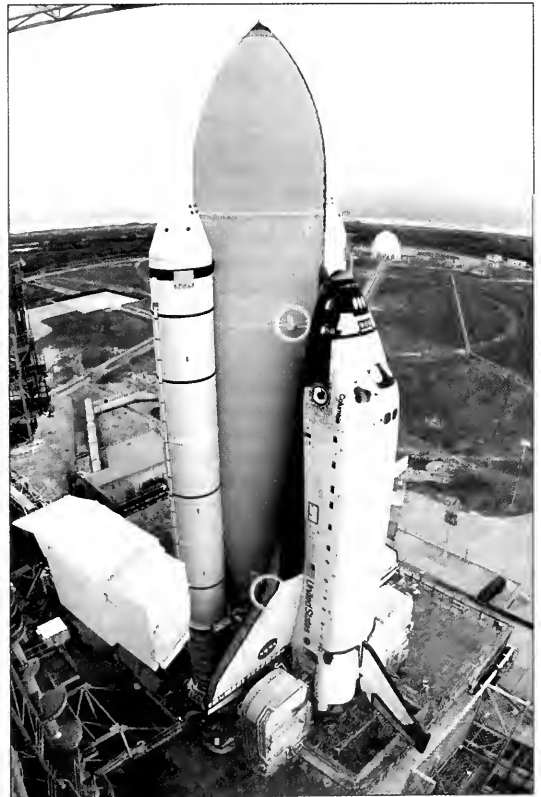
Figure 3.1-1. Columbia sitting at Launch Complex 39-A. The upper circle shows the left bipod (-Y) ramp on the forward attach point, while the lower circle is around RCC panel 8-left.

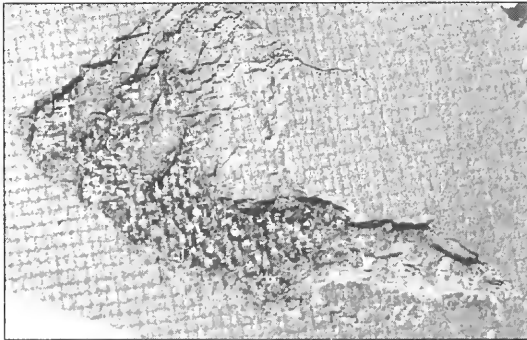
Figure 3.3-2. Damage on the outer surface of RCC panel 10-right from *Atlantis* after STS-45.

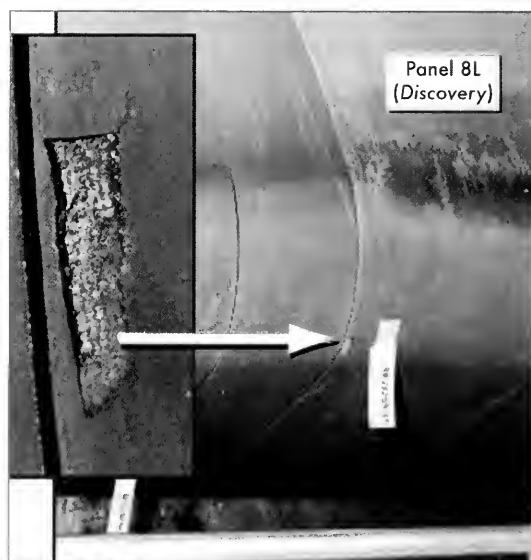
Figure 3.3-5. RCC panel 8-left from *Discovery* had to be scrapped after STS-103 because of the damage shown here.

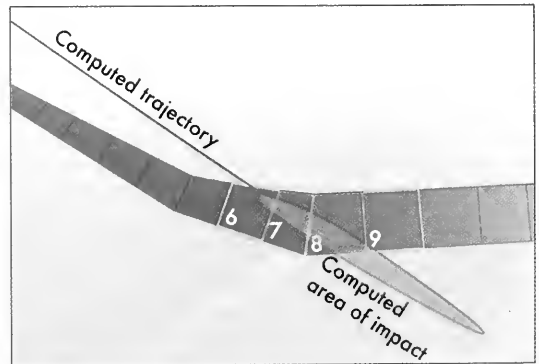
Figure 3.4-3: The best estimate of the site of impact by the center of the foam.

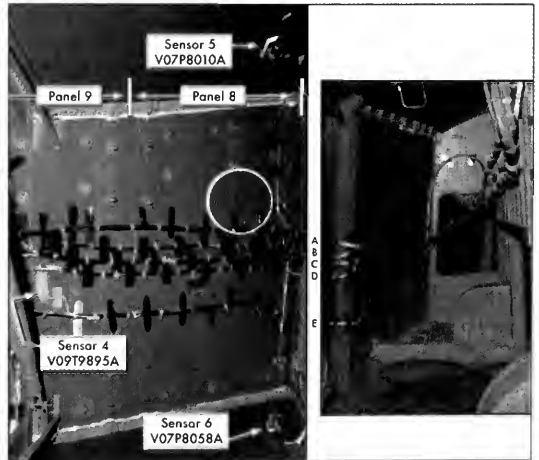
Figure 3.6-8. The left photo above shows the wiring runs on the backside of the wing leading edge behind RCC panel 8 – the circle marks the most likely area where the burn through of the wing leading edge spar initially occurred at EI+487 seconds. The right photo shows the wire bundles as they continue forward behind RCC panels 7 and 6. The major cable bundles in the upper right of the right photo carried the majority of the sensor data inside the wing. As these bundles were burned, controllers on the ground began seeing off-nominal sensor indications.

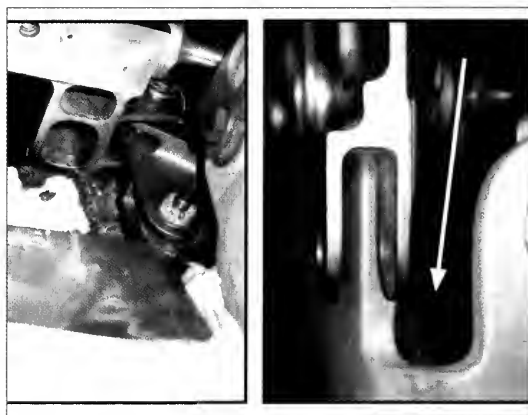
Figure 3.7.2. Each RCC panel has a U-shaped slot (see arrow) in the back of the panel. Once superheated air entered the breach in RCC panel 8, some of that superheated air went through this slot and caused substantial damage to the Thermal Protection System tiles behind this area.

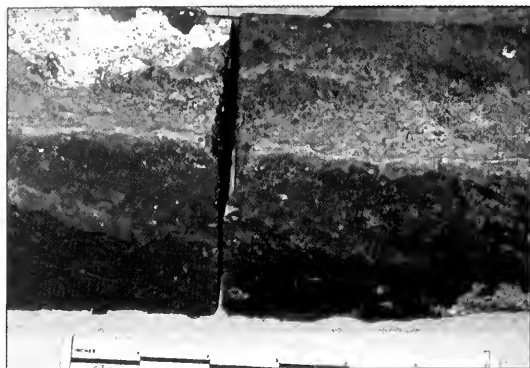
Figure 3.7-3. Superheated airflow caused erosion in tiles around the RCC panel 8 and 9 interface. The tiles shown are from behind the area where the superheated air exited from the slot in Figure 3.7-2. These tiles showed much greater thermal damage than other tiles in this area and chemical analysis showed the presence of metals only found in wing leading edge components.

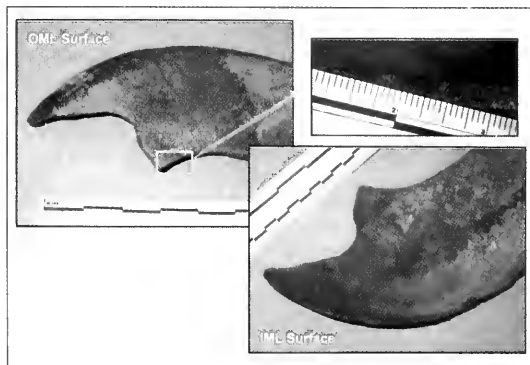
Figure 3.7-4. The outboard rib of panel 8 and the inboard rib of panel 9 showed signs of extreme heating and erosion. RCC erosion of this magnitude was not observed in any other location on the Orbiter.

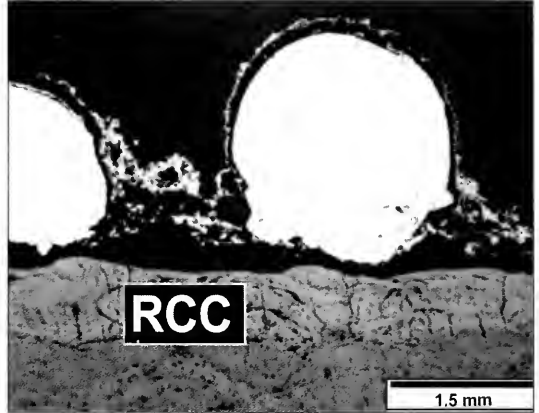
Figure 3.7-8. Spheroids of Inconel 718 and Cerachrome were deposited directly on the surface of RCC panel 8-left. This slag deposit pattern was not seen on any other RCC panels.

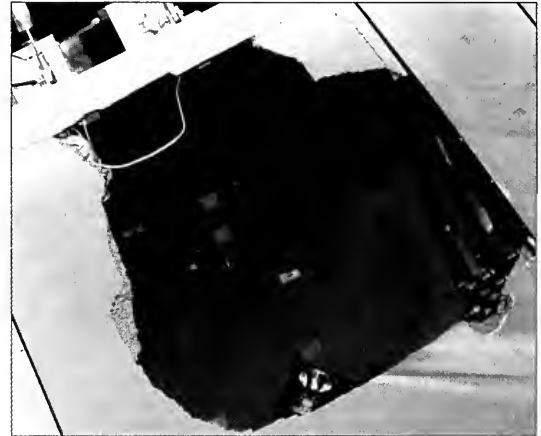
Figure 3.8-9. The large impact hole in Panel 8 from the final test.

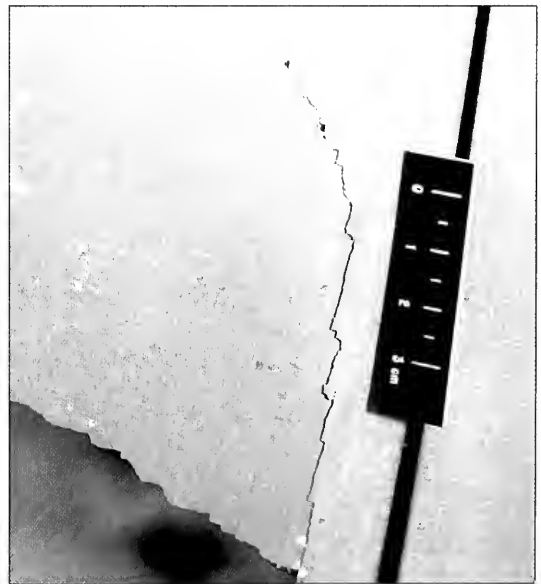
Figure 3.8-10. Numerous cracks were also noted in RCC Panel 8.

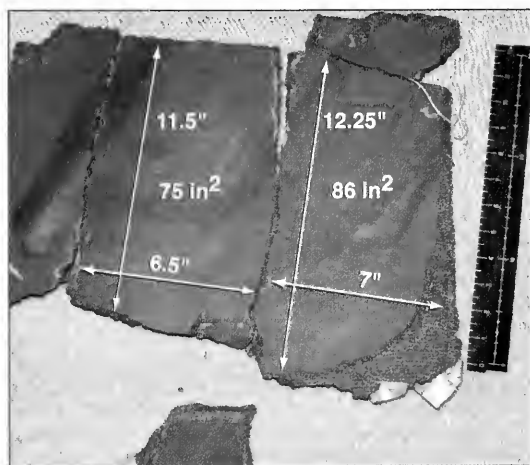
Figure 3.8-11. Three large pieces of debris from the panel face sheet were lodged within the hollow area behind the RCC panel.

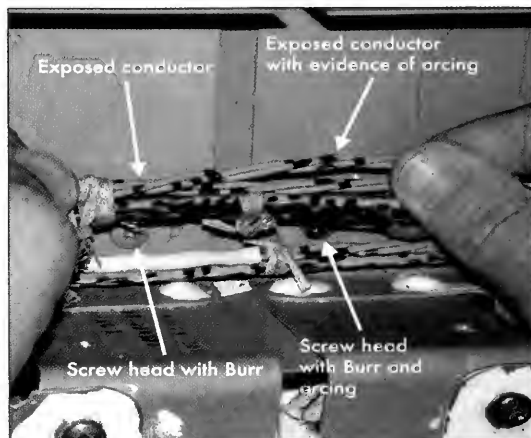
Figure 4.2-2. Arc tracking damage in Kapton wiring.

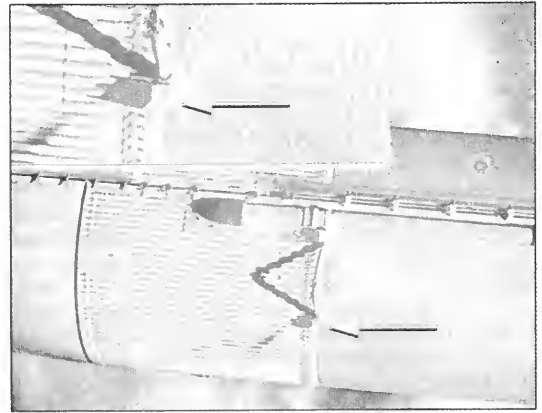
Figure 6.1-3. Only three months before the final launch of Columbia, the bipod ramp foam had come off during STS-112.
